# Manhole Inspection Summary

Manhole # S39K\_\_021MH

Insp Date: **8/20/08 12:39 PM**

**Location** Address: **pier 5**

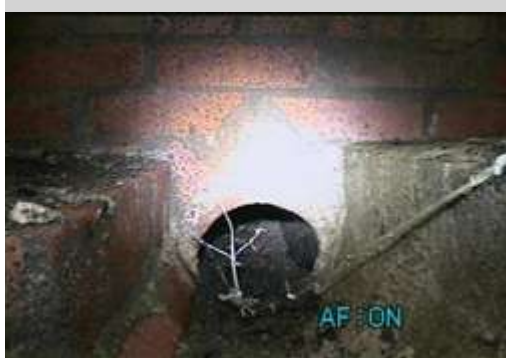
Miscellaneous

channel debris

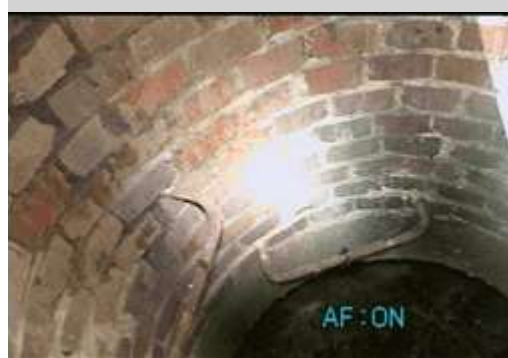
Defect 2

Count: **2** Missing: **0** ☒ **Corroded**

steps

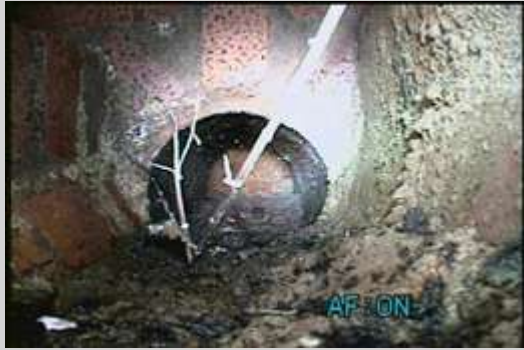
6 O'Clock Inflow

8 in. Circular Gravity Sewer  
Pipe In @ 6 O'Clock

Deposits: ☐ None ☐ Mud ☐ Sludge ☒ Debris ☐ Grease
